National Jute Board | Ministry of Textiles | Govt. of India

CASE STUDIES WITH JUTE GEOTEXTILES (JGT)

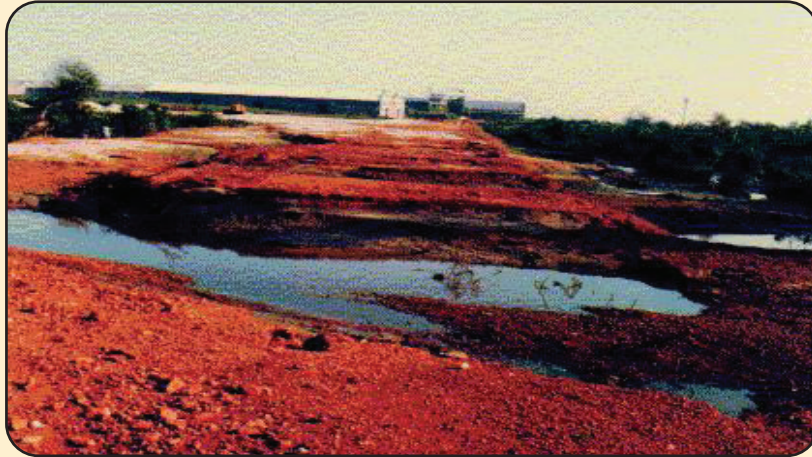
VIEW OF DAMAGED CONDITION OF ROAD

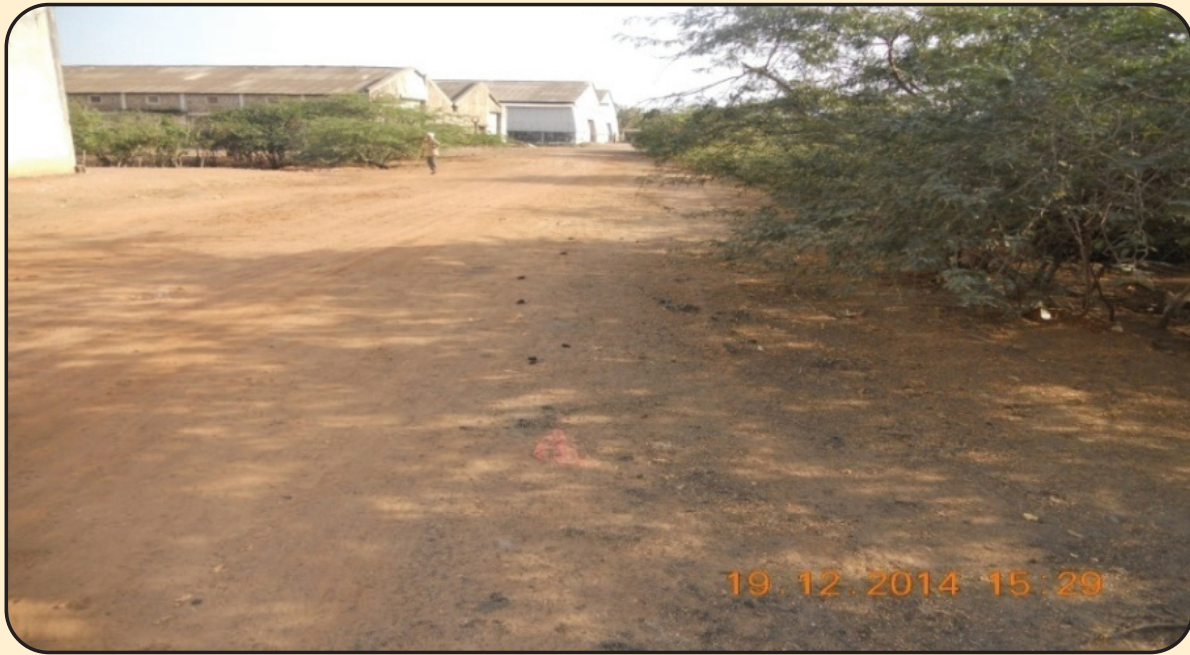
Unpaved road is in good condition with no noticeable distress on surface even after 17 years of construction

VIEW OF CONDITION OF ROAD AFTER 17 YEARS (2014)

(e) It may be mentioned that the stabilized road section was unaffected by the severe cyclone of 6th Nov 1996 in which Kakinada was devastated and the roads in other areas of port were badly damaged.

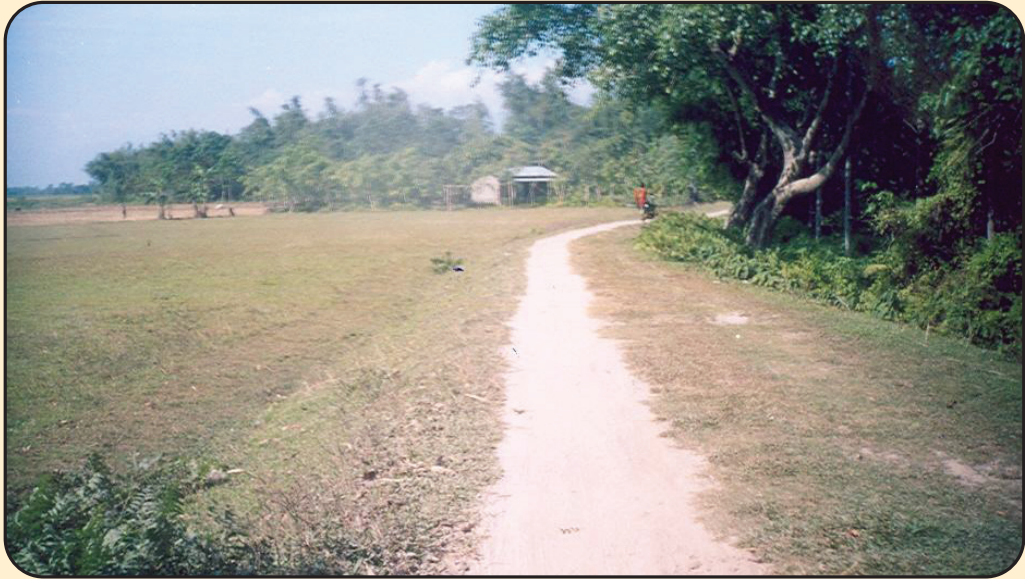
VIEW OF CONDITION OF ROAD BEFORE CONSTRUCTION

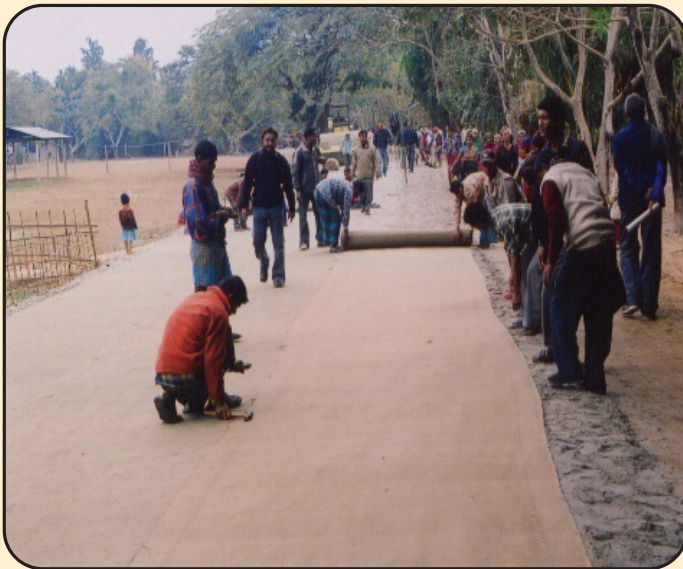
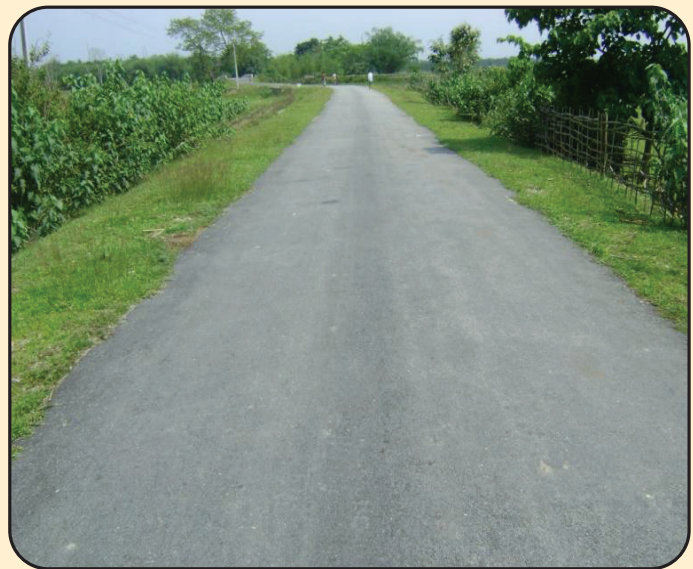
- The blacktop of pavement surface was distress-free during the entire period of performance monitoring.
- Shoulders as well as side slope condition was good without any rain-cuts or settlement with the use of Open Weave JGT at the slope.

VIEW DURING LAYING OF JGT & FINISHED CONDITION ROAD AFTER 23 MONTHS

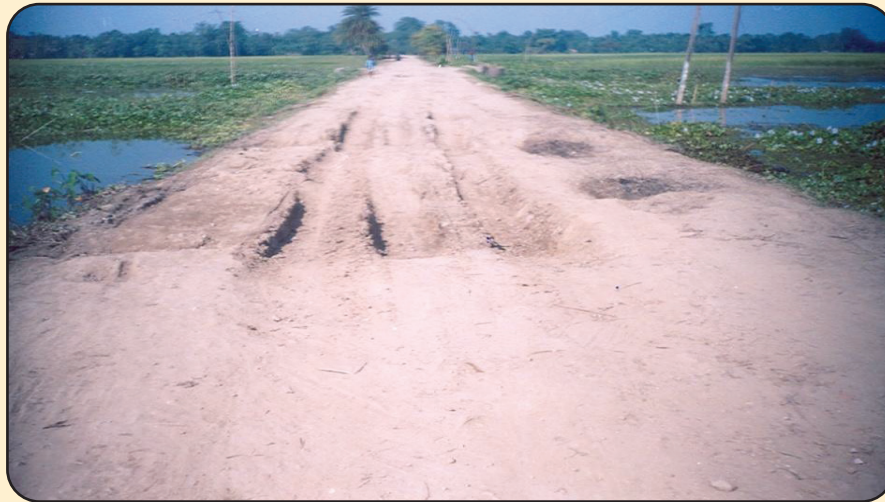
This was an earthen road under PMGSY Pilot Project. Flash flooding of the area does occur occasionally. Deep ruts had formed at some locations. Average annual rainfall of 1500 – 1600 mm observed in the area. The water table is 3 to 4 m below GL during summer and 2 to 3 m during monsoon.

VIEW OF DISTRESSED CONDITION OF ROAD BEFORE CONSTRUCTION

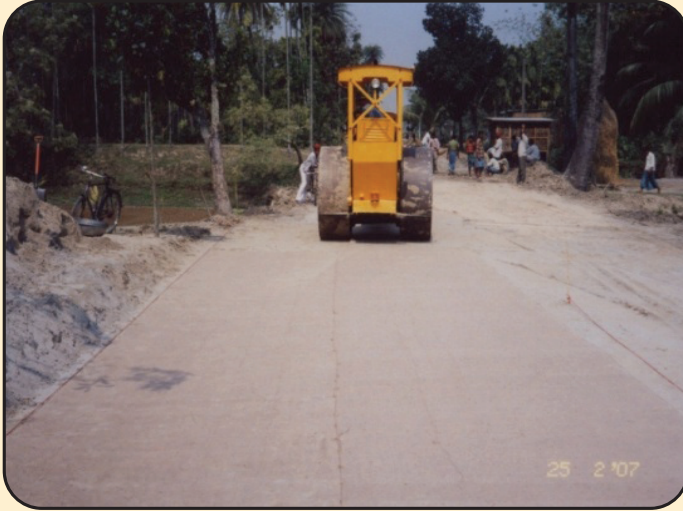
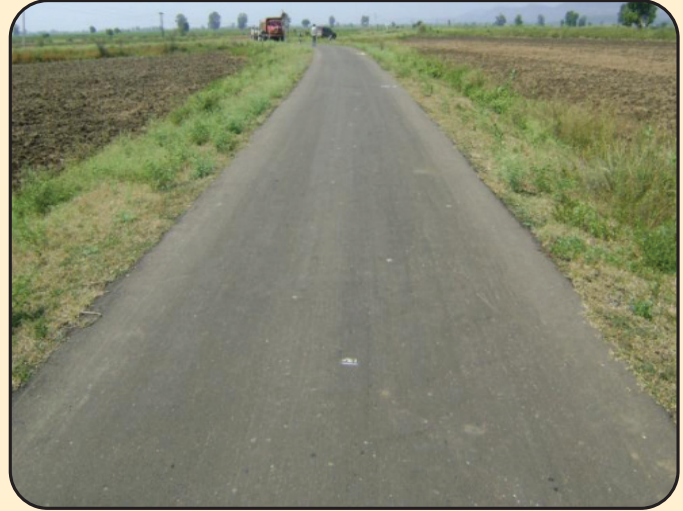
VIEW DURING LAYING OF JGT & FINISHED CONDITION OF ROAD AFTER 2 YEARS

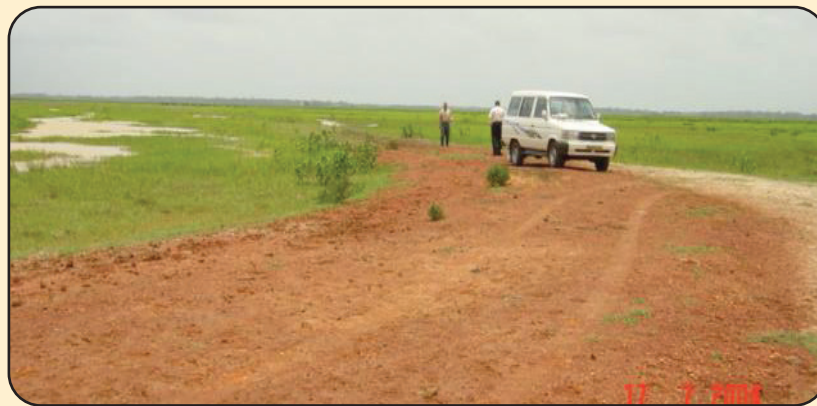
VIEW OF CONDITION OF ROAD BEFORE CONSTRUCTION

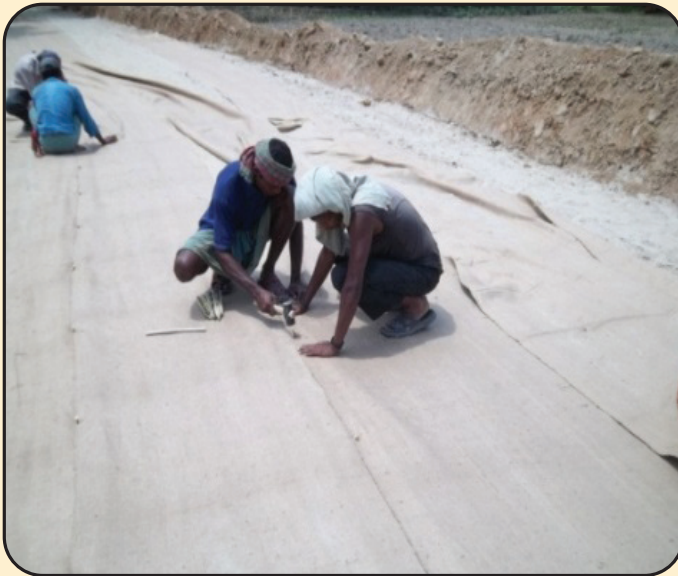
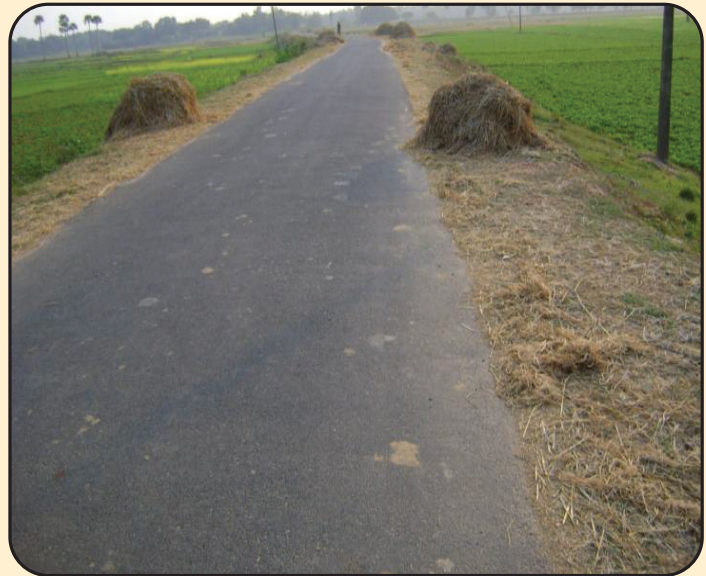
- The blacktop of pavement surface was distress-free during the entire period of performance monitoring
- Shoulders as well as side slope condition were in good shape without any rain-cut or settlement with the use of Open Weave JGT at the slope..

VIEW DURING LAYING OF JGT & FINISHED CONDITION OF ROAD AFTER 31 MONTHS

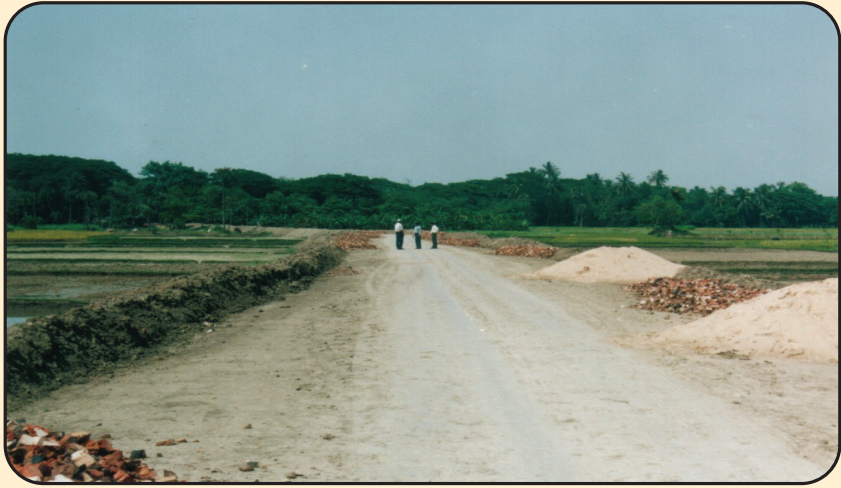
VIEW OF CONDITION OF ROAD BEFORE CONSTRUCTION

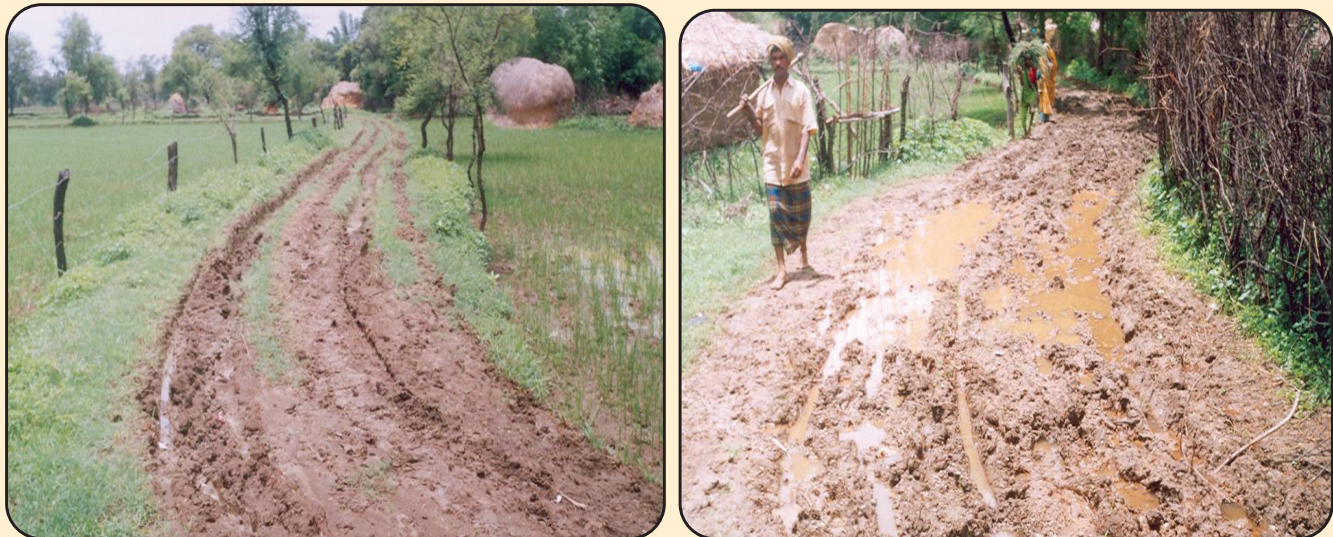
This was an earthen road under PMGSY Pilot project. The soil type was black cotton soil of high compressibility that led to deep ruts under the wheel paths over a major portion of the length. Average annual rainfall observed as 1000 mm. The earthen track transverses through both plain and rolling terrain, water table found to be about 3 to 4 m below GL.

VIEW OF CONDITION OF ROAD BEFORE CONSTRUCTION

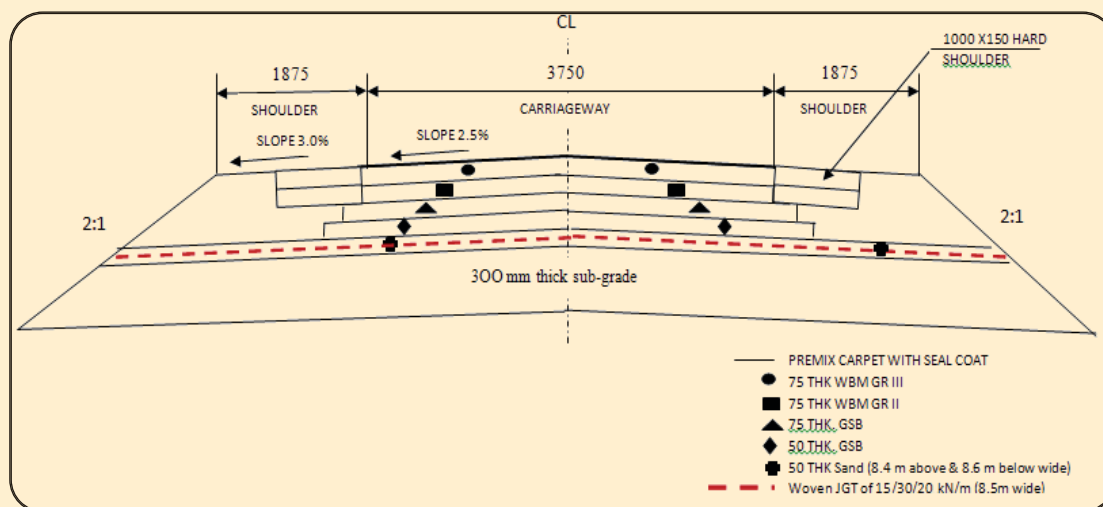
CROSS-SECTIONAL DETAILS OF PAVEMENT WITH JUTE GEOTEXTILE

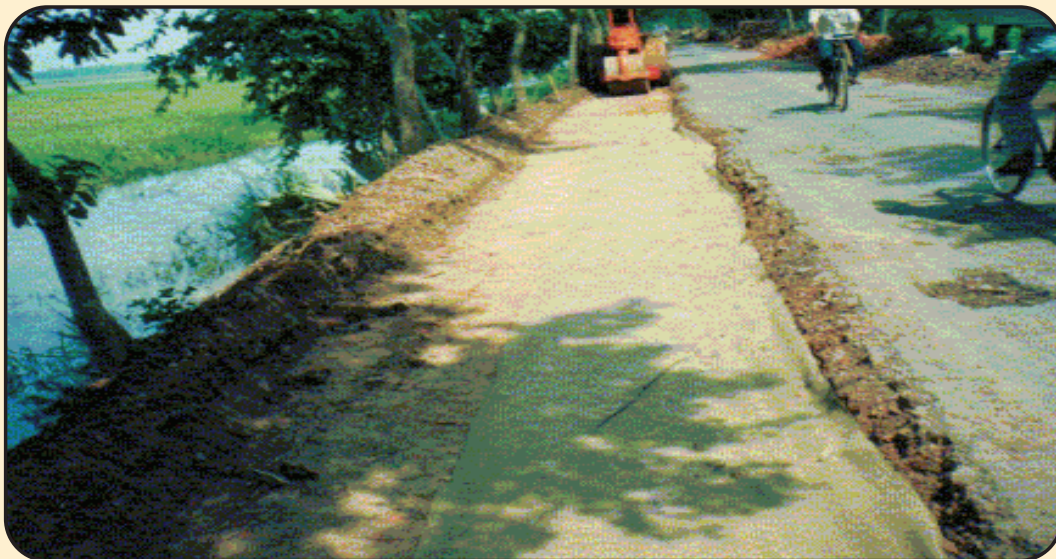
VIEW OF ROAD DURING WIDENING

JGT laid over sub-grade

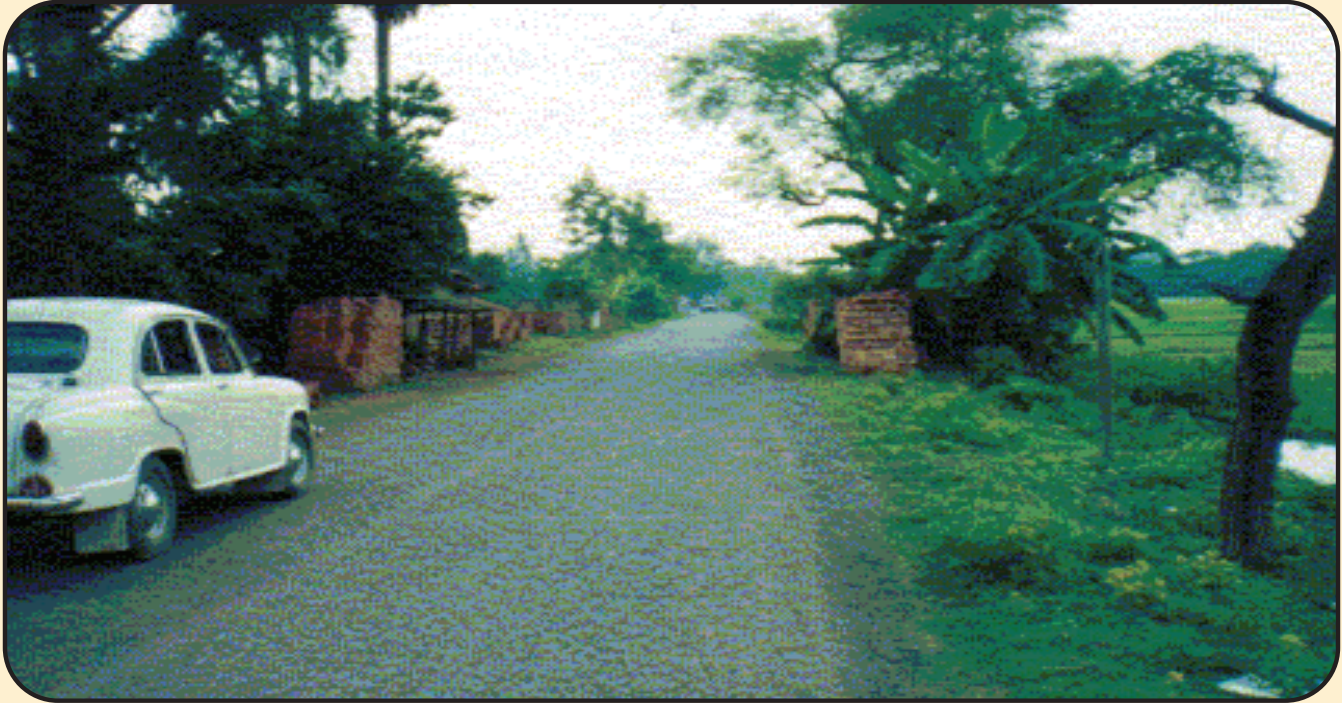
VIEW OF FINISHED CONDITION ROAD AFTER 1 YEAR

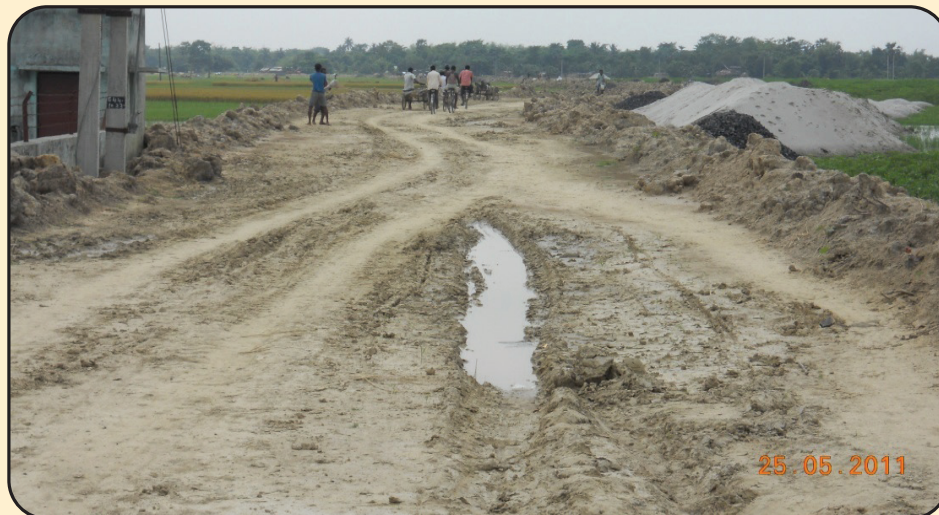
VIEW OF CONDITION OF ROAD BEFORE CONSTRUCTION

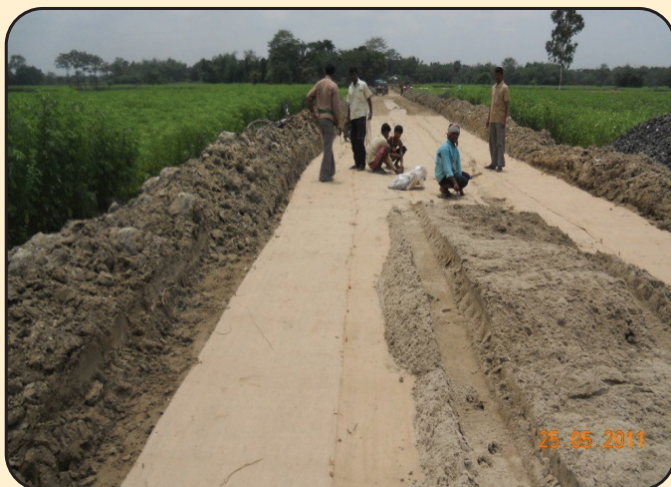
Layer of sand spread over JGT

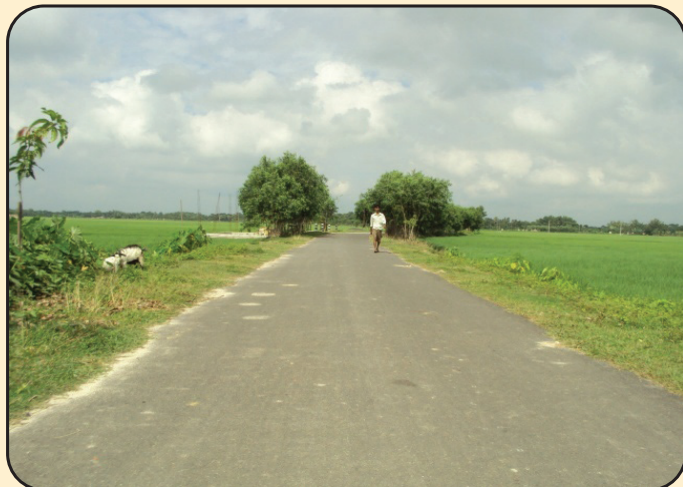
- The riding surface is in good condition with no sign of distresses
- No pot holes or rutting observed.
- Shoulders as well as side slope condition is in good condition without any rain-cuts or settlement at the slope.

Finished Condition of road after 3 years (2015)

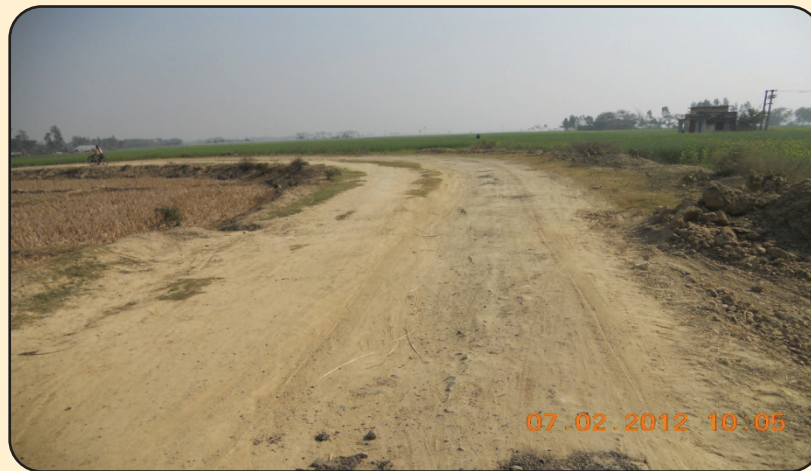
VIEW OF CONDITION OF ROAD BEFORE CONSTRUCTION

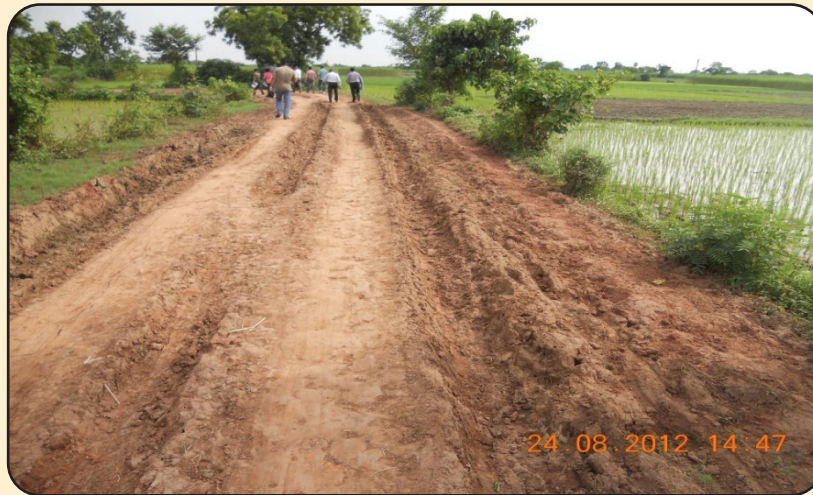
VIEW OF CONDITION OF ROAD BEFORE CONSTRUCTION

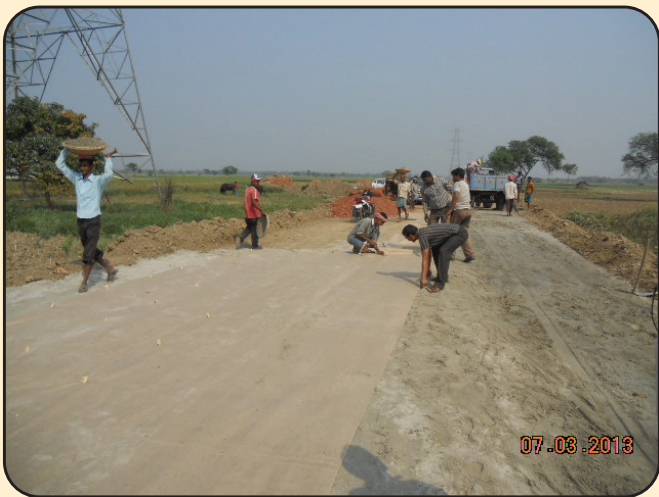
JGT laid over sand

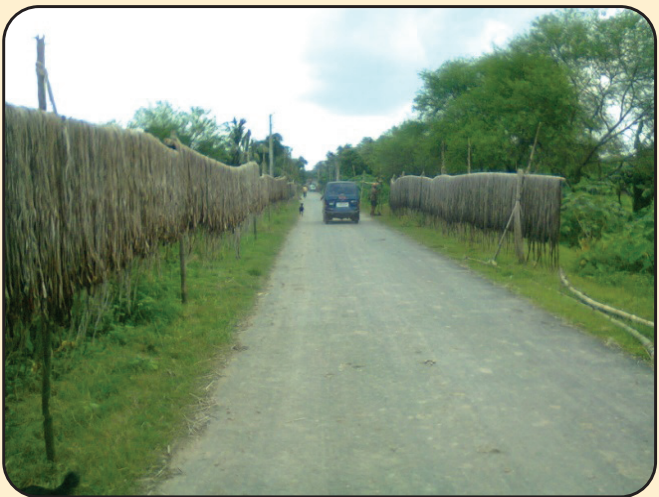
- The riding surface is in good condition with no sign of distresses
- No pot holes or rutting observed.
- Shoulders as well as side slope condition is in good condition without any rain-cuts or settlement at the slope.

Finished Condition of road after 1 year (2015)

Note : The movement of heavy loaded truck of about 25 – 30 tonnes carrying sand, bricks on this road has increased immensely to about 30-35 passes in a day.

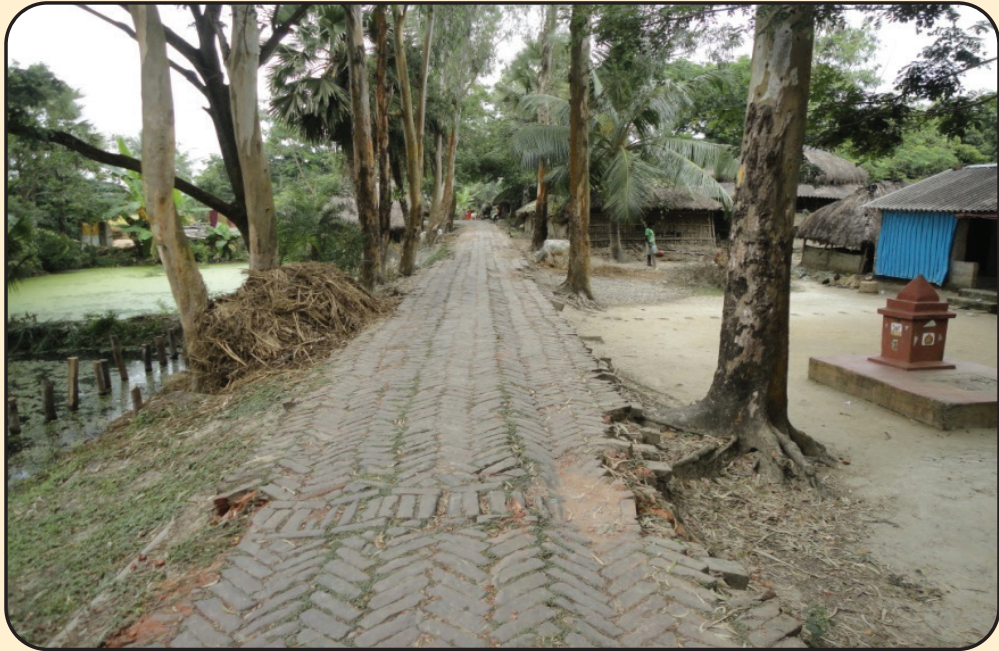
VIEW OF CONDITION OF ROAD BEFORE CONSTRUCTION

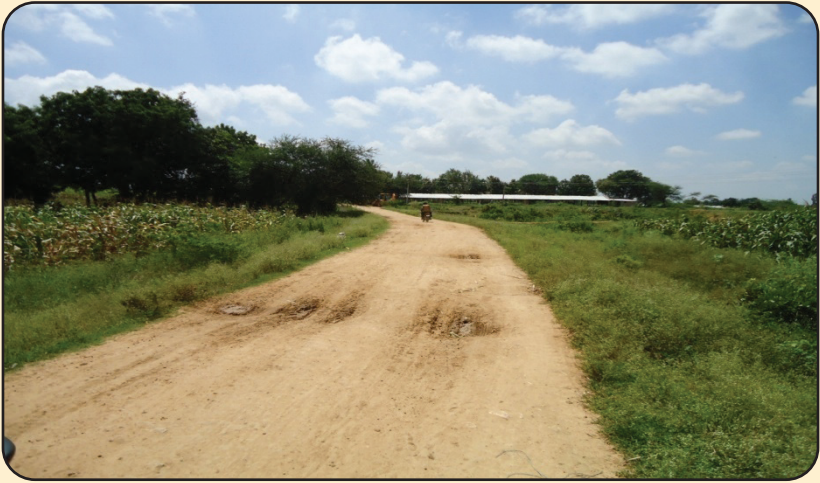
VIEW OF CONDITION OF ROAD BEFORE CONSTRUCTION

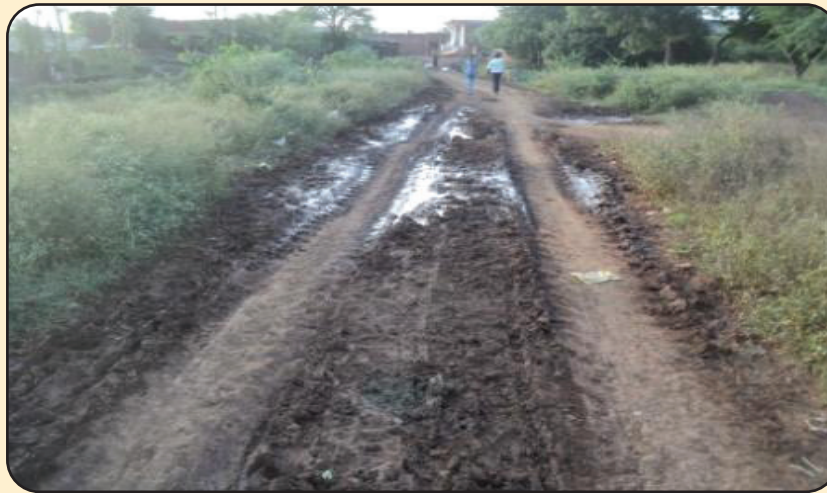
VIEW OF CONDITION OF ROAD BEFORE CONSTRUCTION

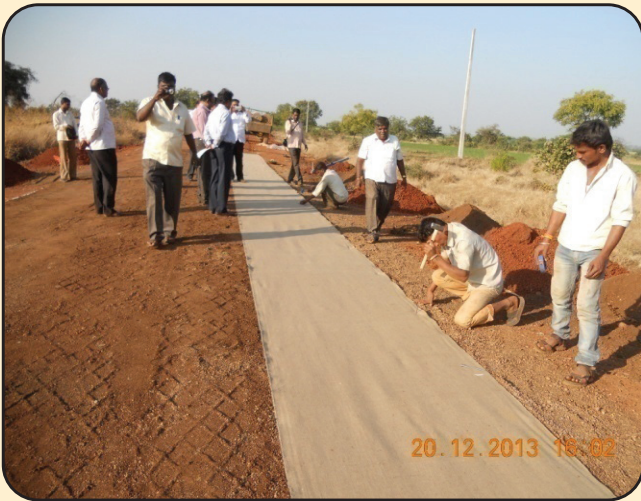
Pegging of JGT

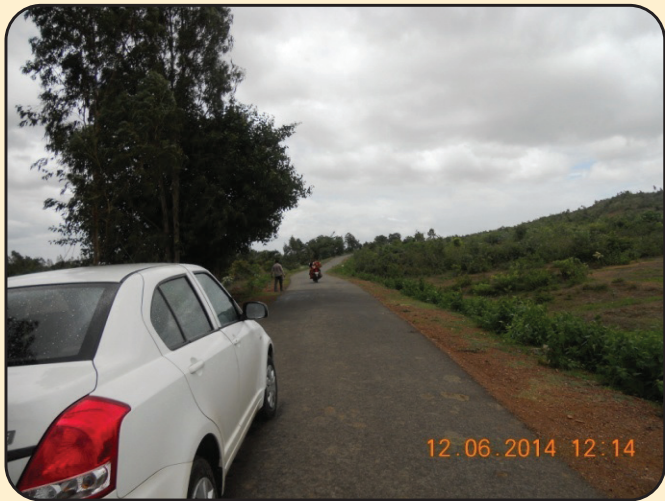
- The riding surface is in good condition with no sign of distresses
- No pot holes or rutting observed.
- Shoulders as well as side slope condition is in good condition without any rain-cuts or settlement at the slope.

Finished Condition of road after 1½ year (2015)

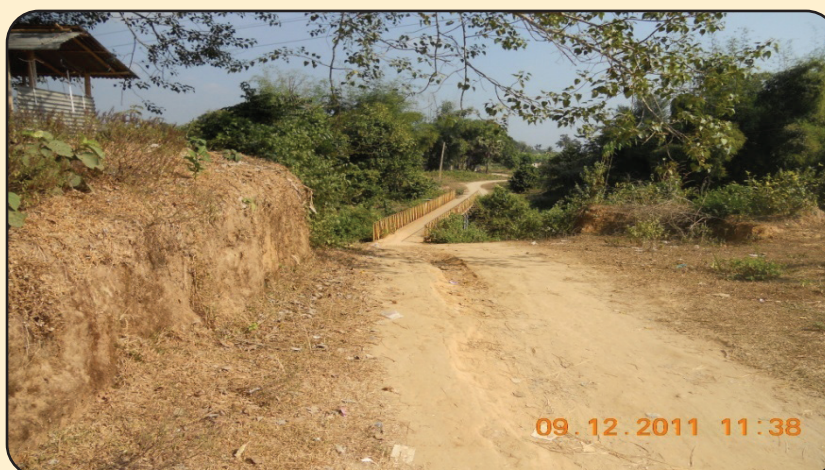
VIEW OF CONDITION OF ROAD BEFORE CONSTRUCTION

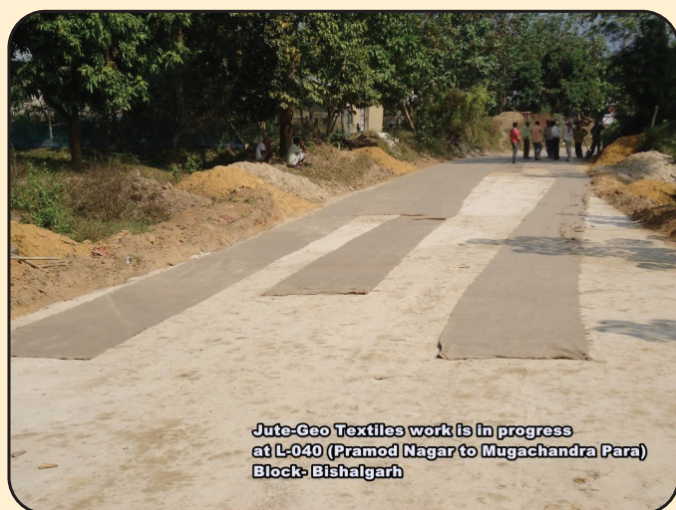
Laying of JGT

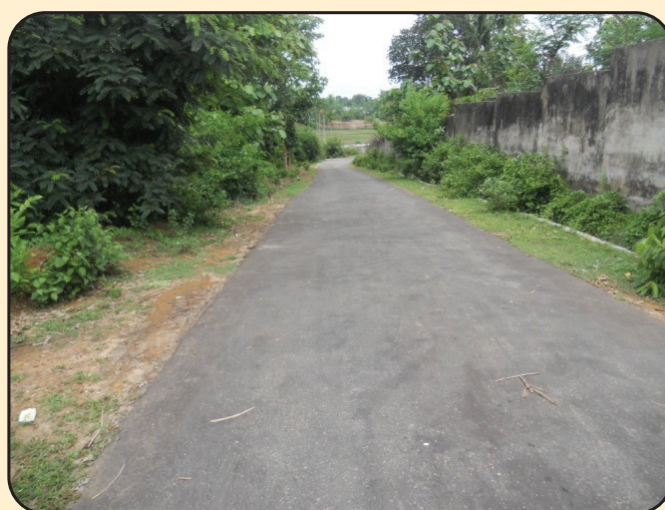
- The riding surface is in good condition with no sign of distresses
- No pot holes or rutting observed.
- Shoulders as well as side slope condition is in good condition without any rain-cuts or settlement at the slope.

Finished Condition of road after 2 years (2015)

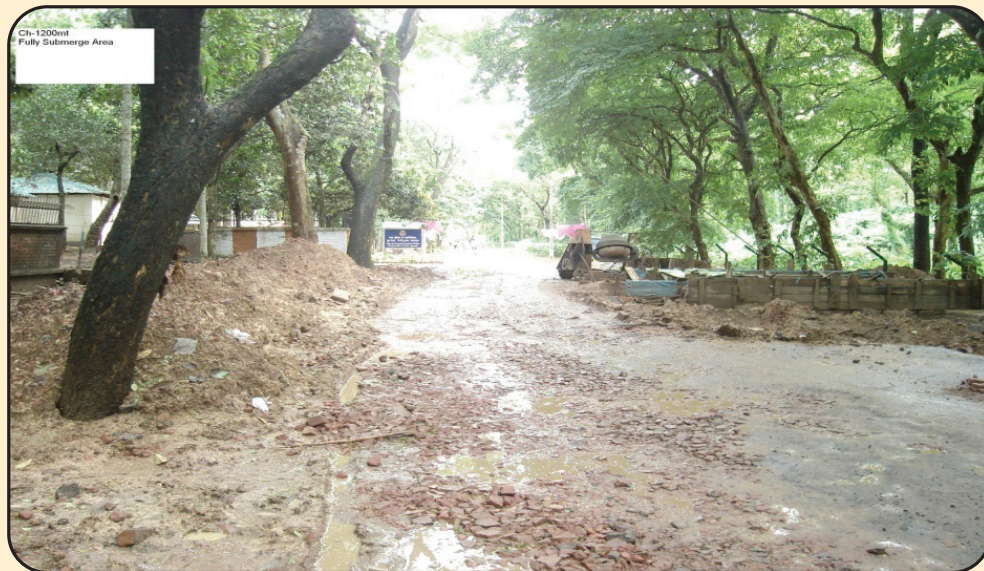
VIEW OF CONDITION OF ROAD BEFORE CONSTRUCTION

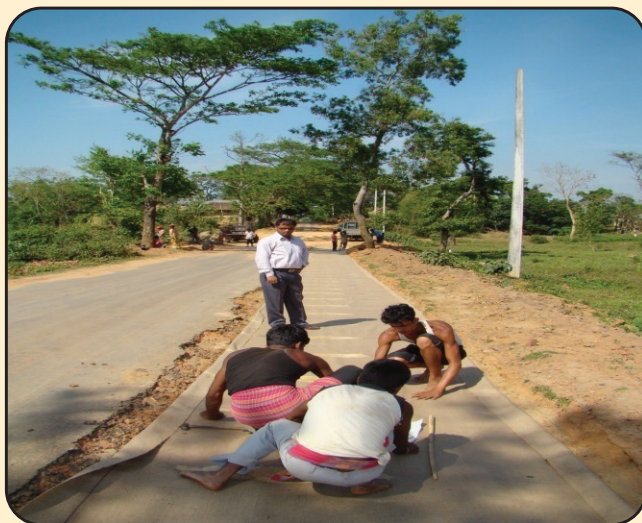
Laying of JGT in widened portion

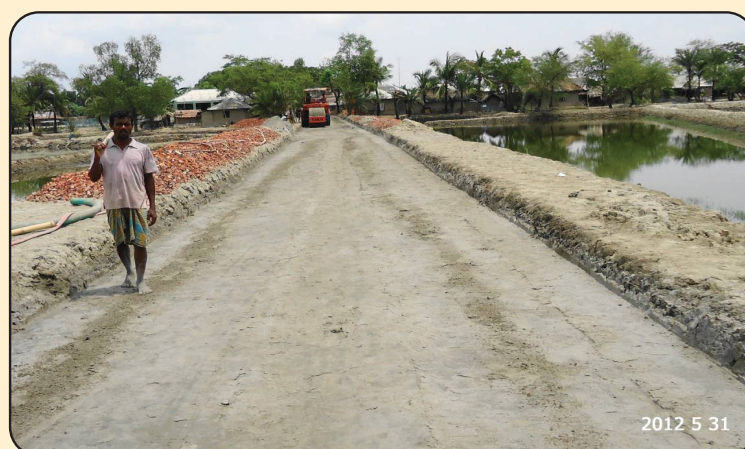
VIEW OF CONDITION OF ROAD BEFORE CONSTRUCTION

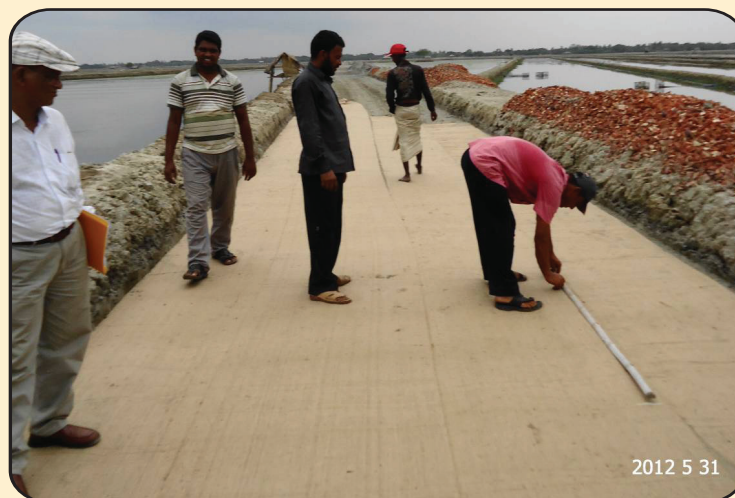
VIEW OF LAYING OF JGT & FINISHED CONDITION ROAD

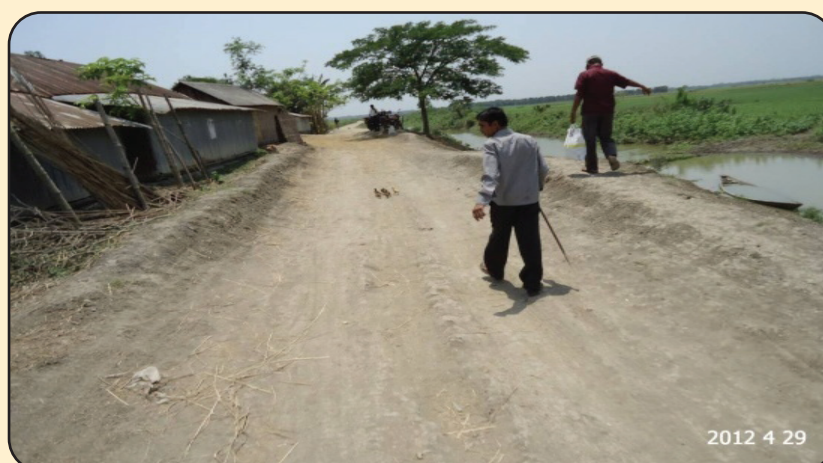
VIEW OF CONDITION OF ROAD BEFORE CONSTRUCTION

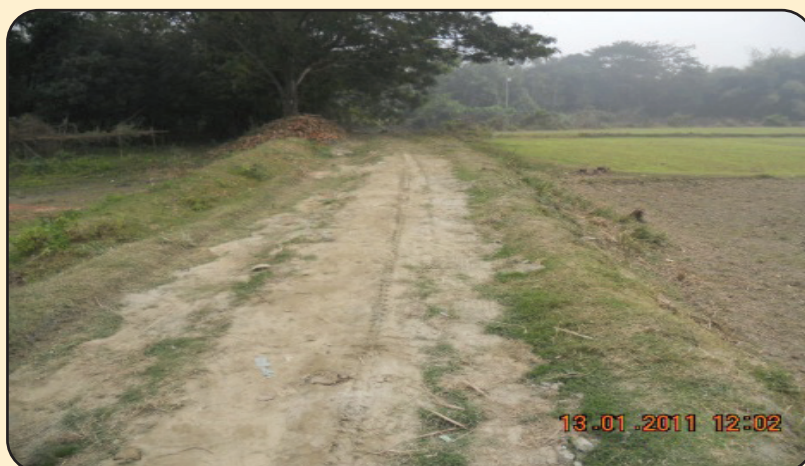
VIEW OF CONDITION OF ROAD BEFORE CONSTRUCTION

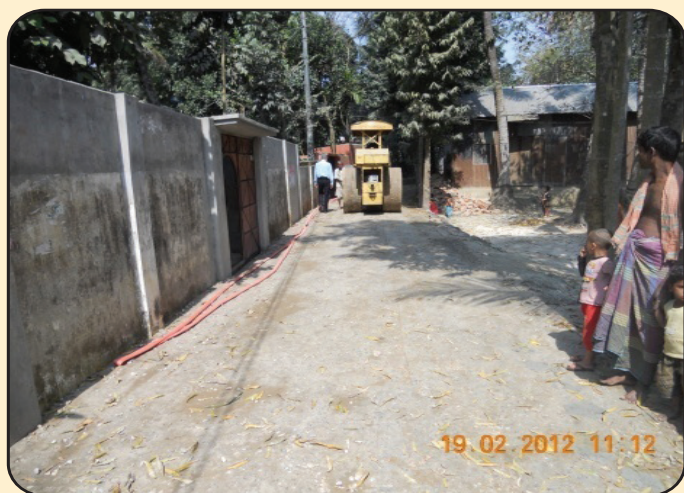
VIEW OF DURING CONSTRUCTION & FINISHED CONDITION ROAD

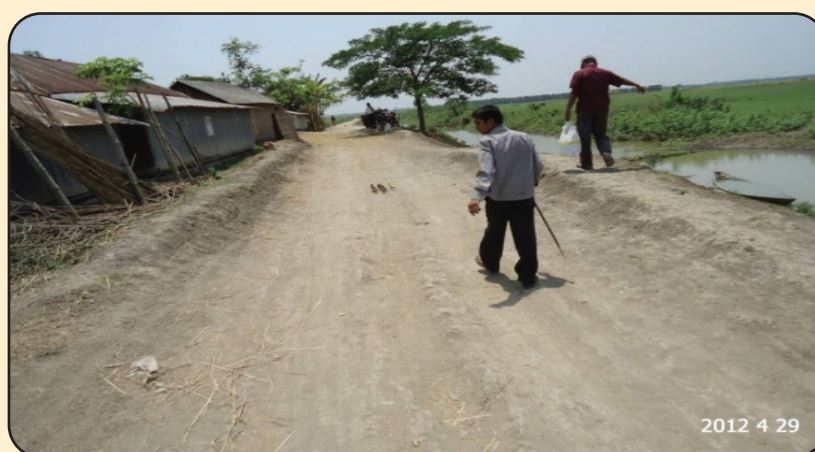
VIEW OF CONDITION OF ROAD BEFORE CONSTRUCTION

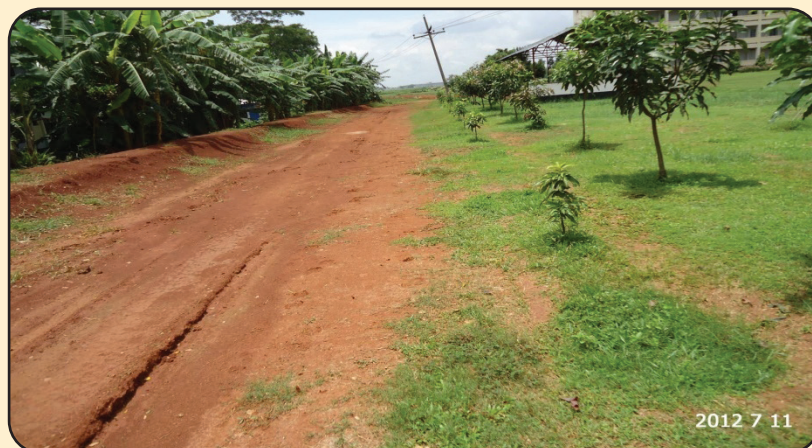
VIEW OF CONDITION OF ROAD BEFORE CONSTRUCTION

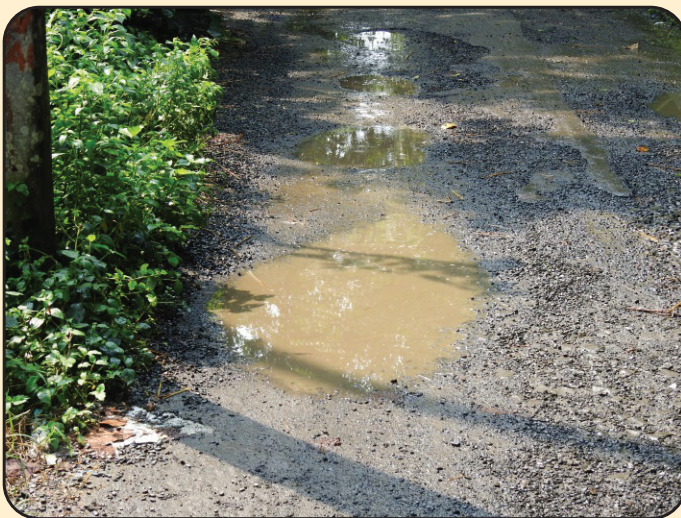
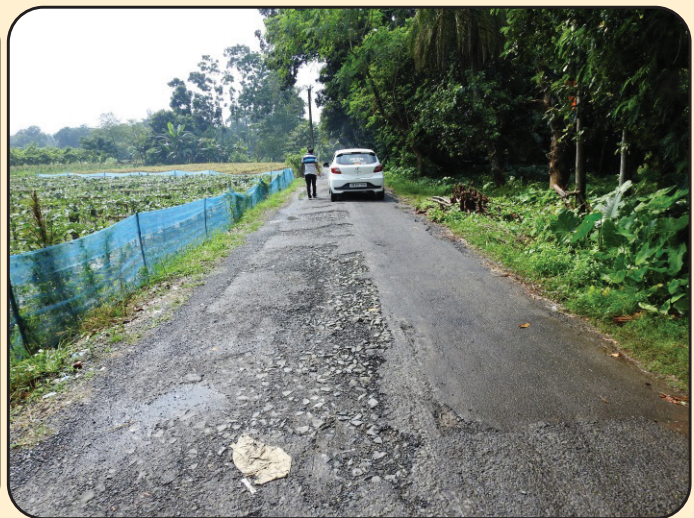
VIEW OF CONDITION OF ROAD BEFORE CONSTRUCTION

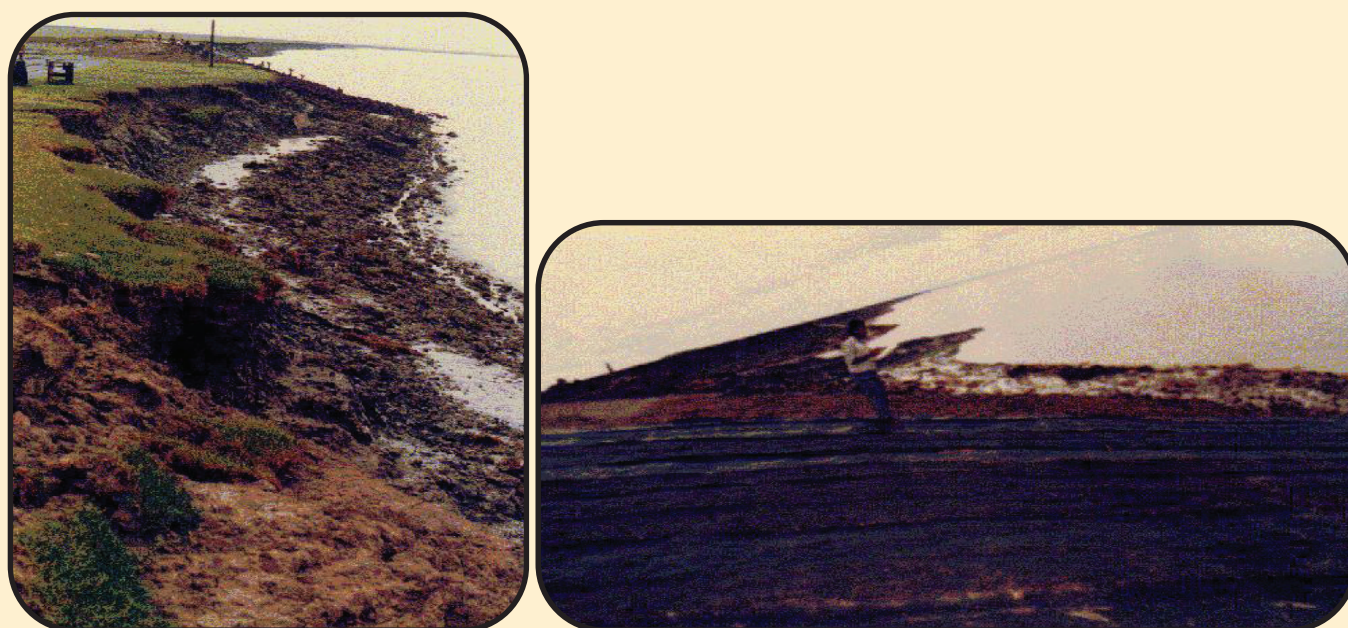
VIEW DURING LAYING OF JGT

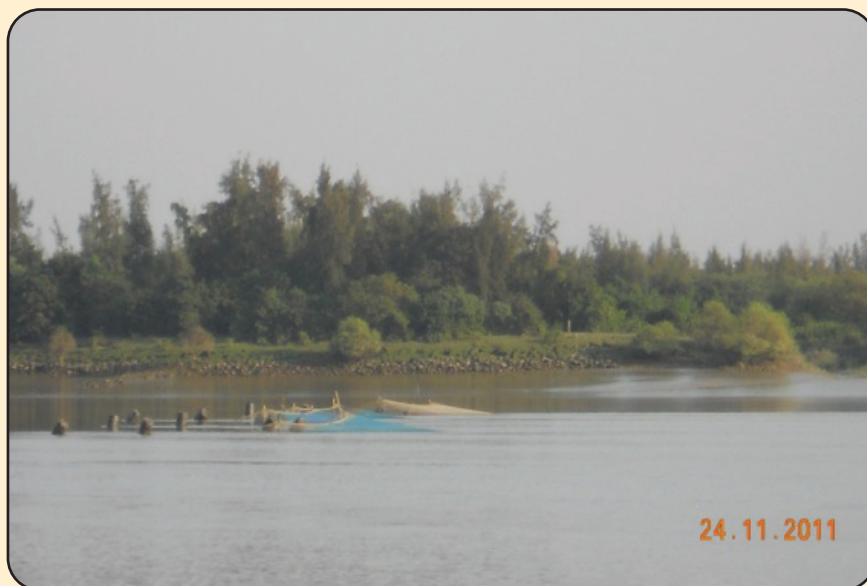
- Entire stretch of JGT treated portion is in good shape with no distresses observed even after 2 decades.
- Even in high tidal fluctuations and high salinity, JGT worked satisfactorily.
- Submerged granular spurs were constructed at some places for neutralizing effects of eddies at the bank toe.
- The growth of mangrove seedlings planted through JGT could not rise above the thickness of sediment deposited on the bank implying that the rate of growth of mangrove seedlings was less than siltation rate at the particular location.

VIEW OF CONDITION RIVERBANK AFTER TWO DECADES OF JGT APPLICATION

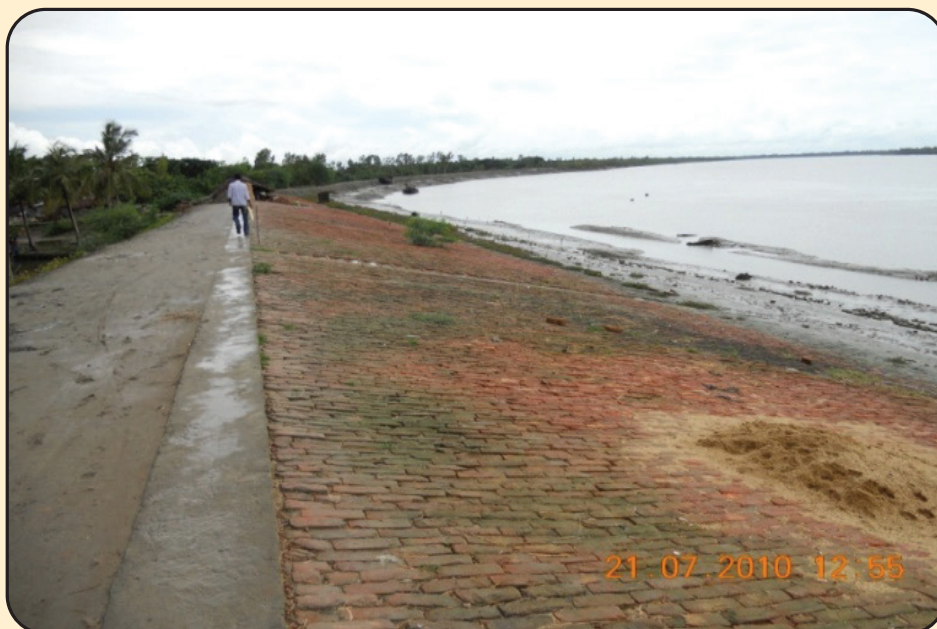
- Entire portion of JGT treated portion of bank is stabilized and in good shape with no distresses observed even after two and half years.
- Even in high tidal fluctuations and high salinity JGT worked satisfactorily in the eroded bank section treated with JGT.

VIEW OF CONDITION RIVERBANK AFTER TWO AND HALF YEARS OF JGT APPLICATION

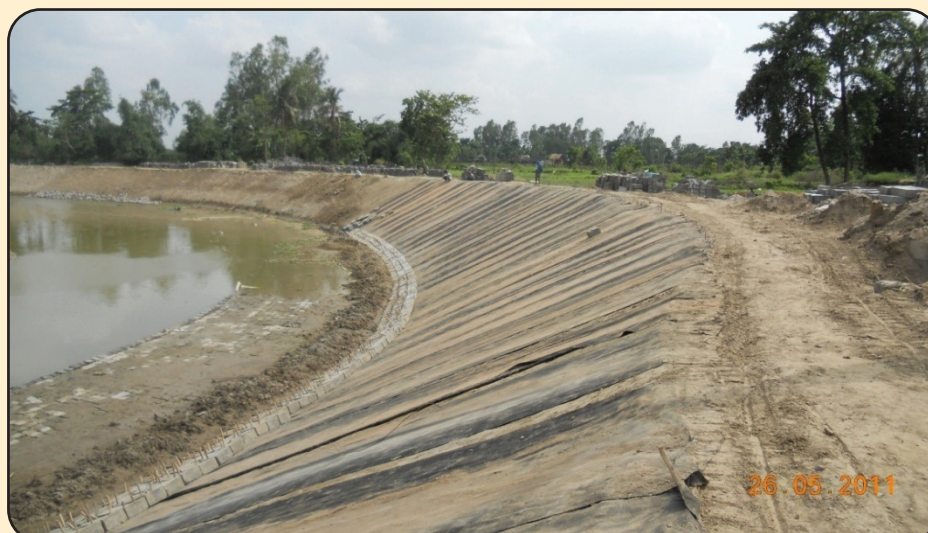
VIEW DURING LAYING OF JGT

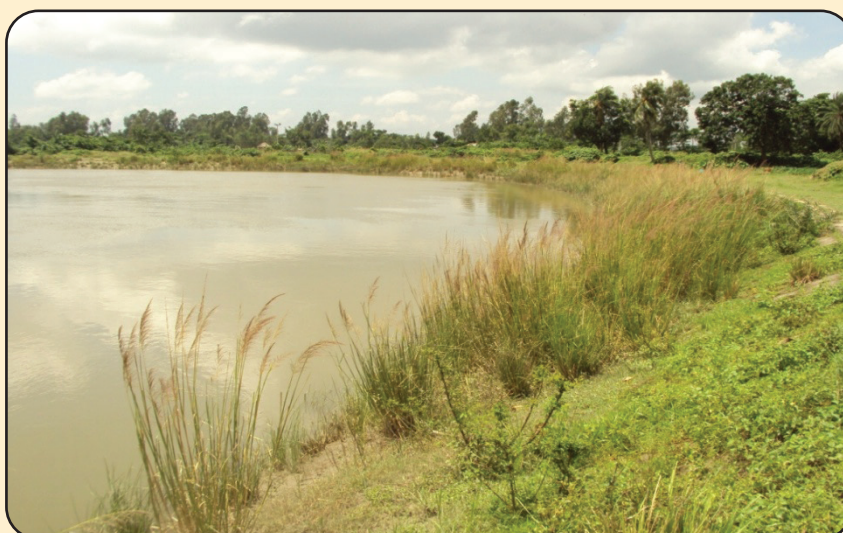
- Entire stretch of JGT treated portion is in good shape with no distresses observed even after more than 3 years.
- Dense growth of vegetation is observed in entire stretch of bank treated with JGT.
- Even in concavity portion of bank where the impact of flood water is higher, JGT worked satisfactorily.

VIEW OF CONDITION RIVER BANK AFTER THREE YEARS OF JGT APPLICATION

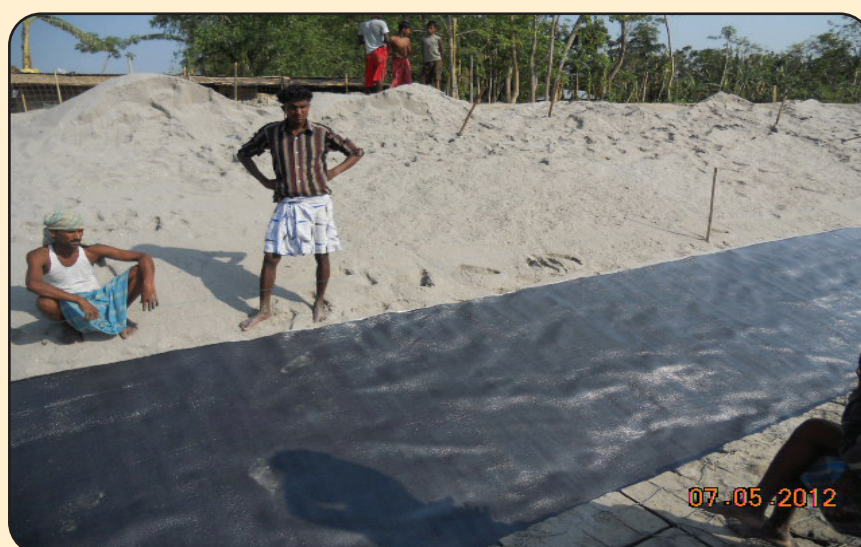
VIEW DURING LAYING OF JGT
