National Jute Board | Ministry of Textiles | Govt. of India

CASE STUDIES WITH JUTE GEOTEXTILES (JGT)

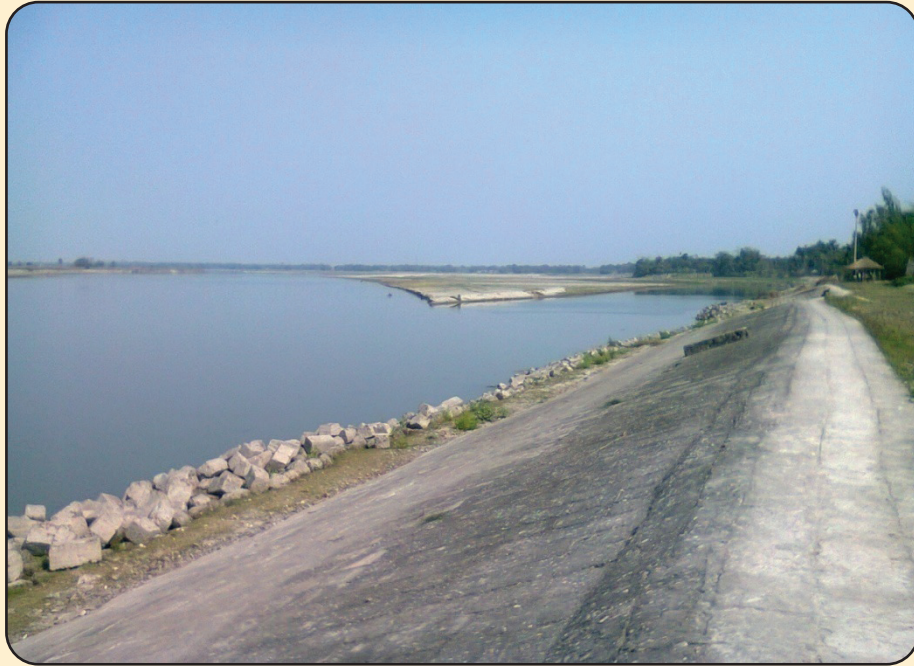
- Entire stretch of JGT treated portion is in good shape with no distresses observed even after 3 years.
- Even in such high discharge of five rivers together, bank treated with JGT worked satisfactorily.

VIEW OF CONDITION RIVER BANK AFTER THREE YEARS OF JGT APPLICATION

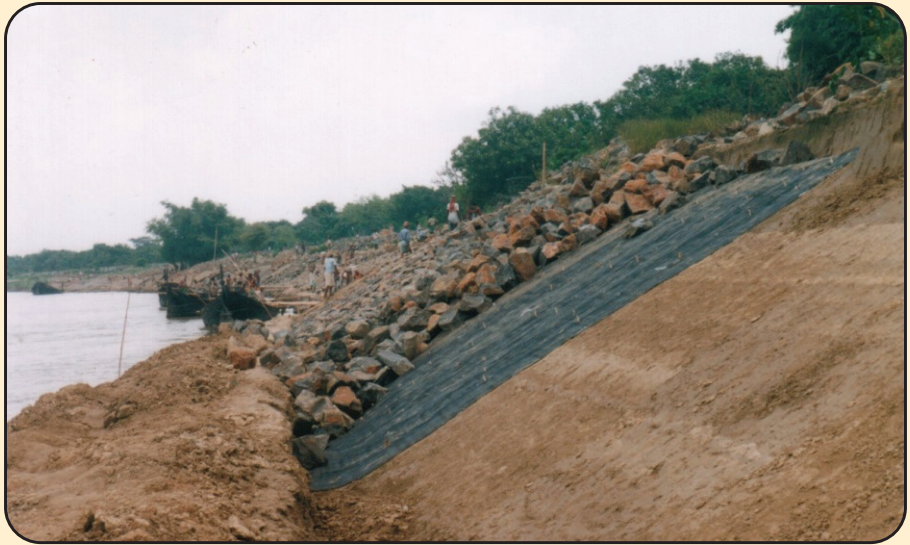
VIEW DURING LAYING OF JGT

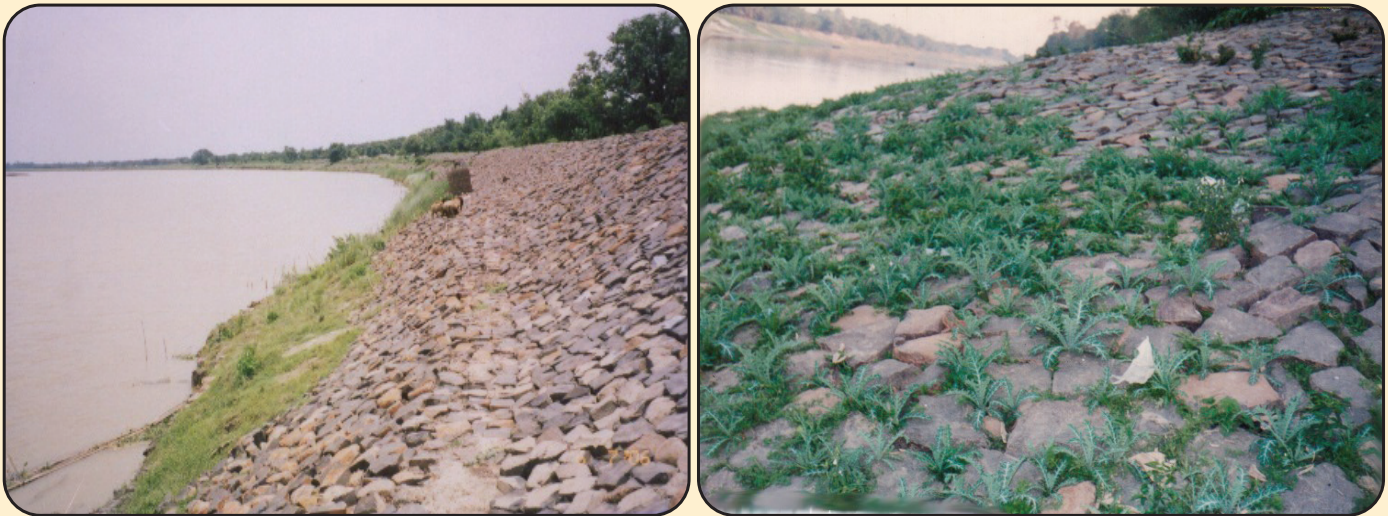
- Entire stretch of JGT treated portion is in good shape with no distresses observed even after more than 3 years.
- Dense growth of vegetation is observed in entire stretch of bank treated with JGT.
- Even in concavity portion of bank where the impact of flood water is higher, JGT worked satisfactorily.
- Based on excellent performance of JGT, I & WD Deptt. has undertaken the bank protection work with JGT in other stretches of the same river.

VIEW OF CONDITION RIVER BANK AFTER THREE YEARS OF JGT APPLICATION

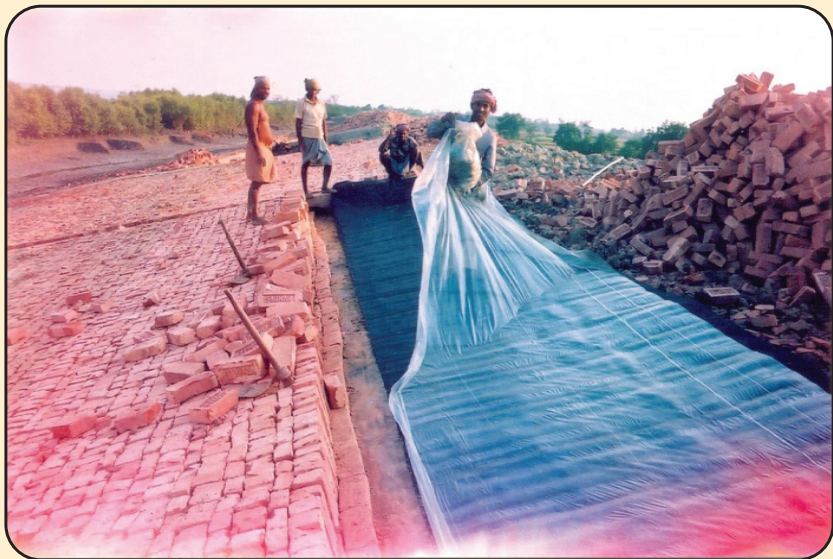
VIEW DURING LAYING OF JGT

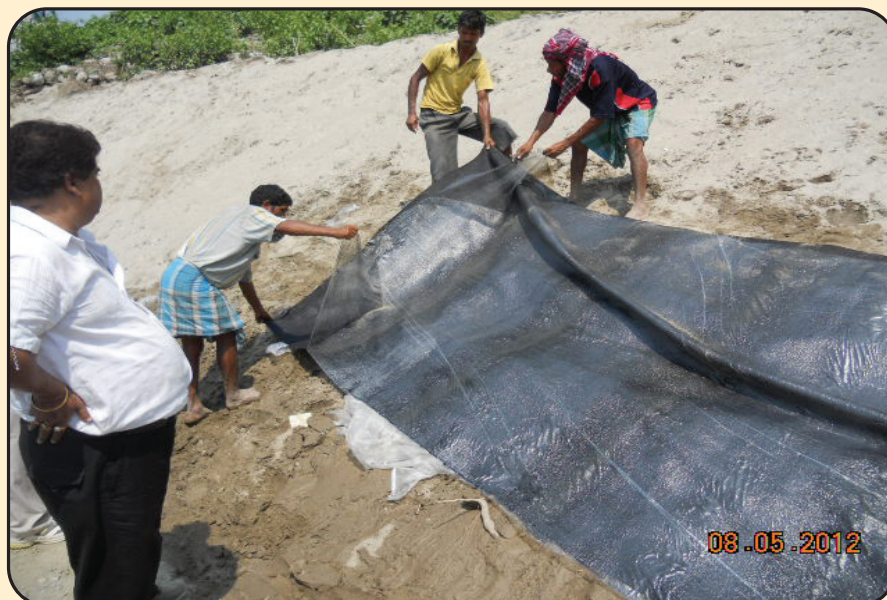
VIEW DURING LAYING OF JGT

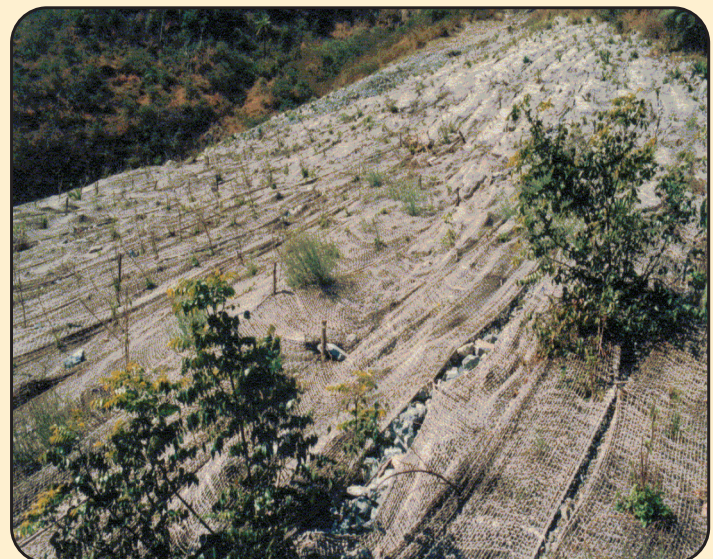
VIEW AFTER LAYING OF JGT & SPROUTING OF SEEDLINGS THROUGH JGT

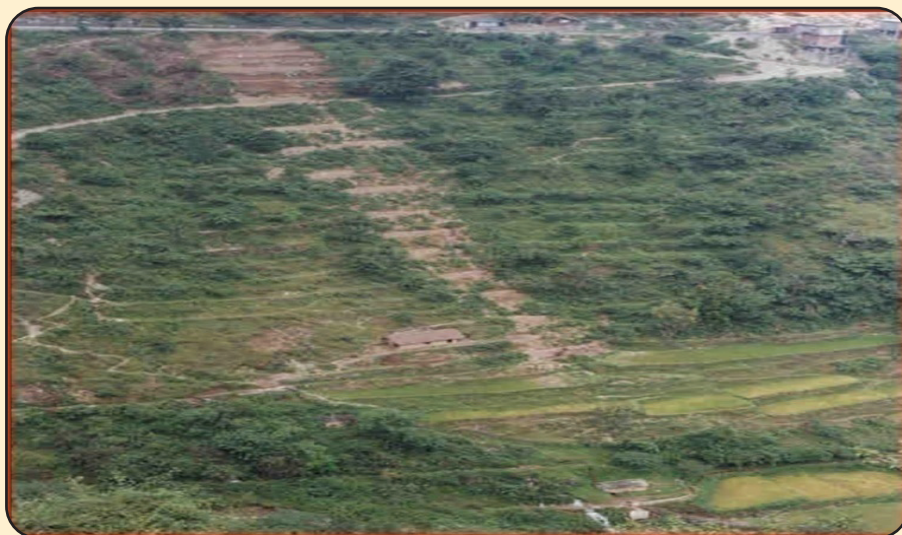
(a) JGT degraded in about 2 years, by then vegetation cover had established itself providing good anchorage to soil.

VIEW OF STABILIZED MINE SPOIL TREATED WITH JGT AFTER 9 YEARS

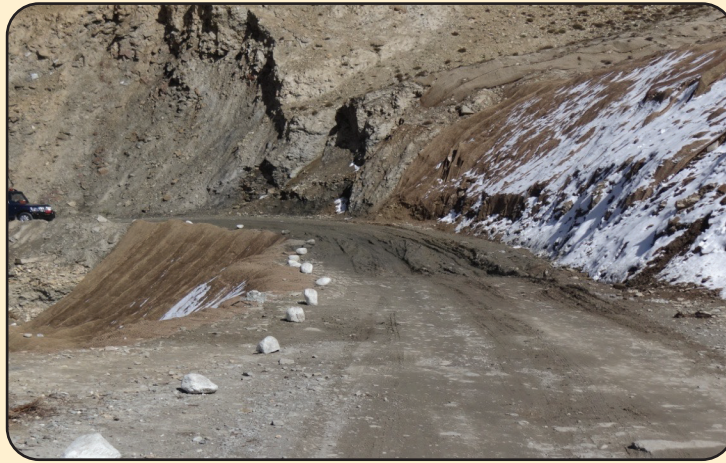
VIEW AFTER LAYING OF JGT & FORMATION OF SNOW OVER JGT

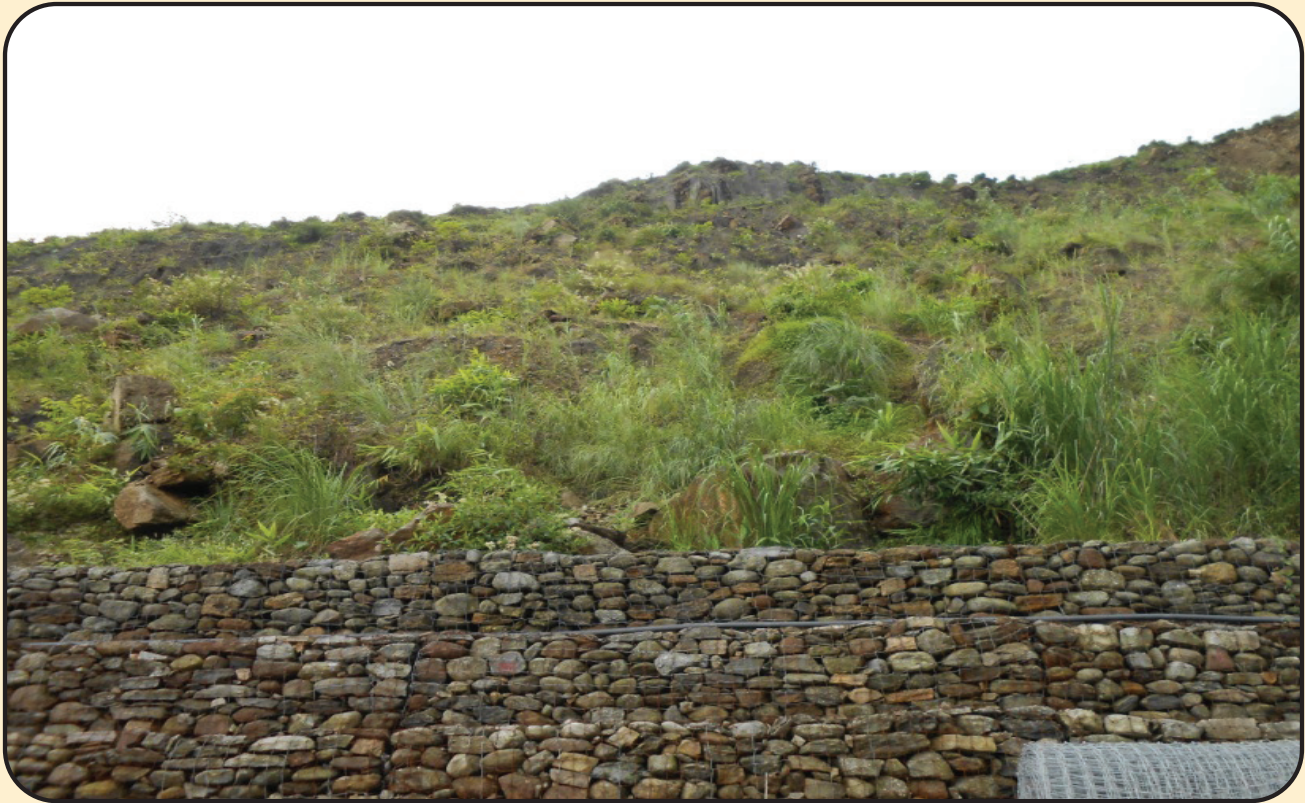
VIEW AFTER SLOPE STABILIZATION AND GROWTH OF VEGETATION

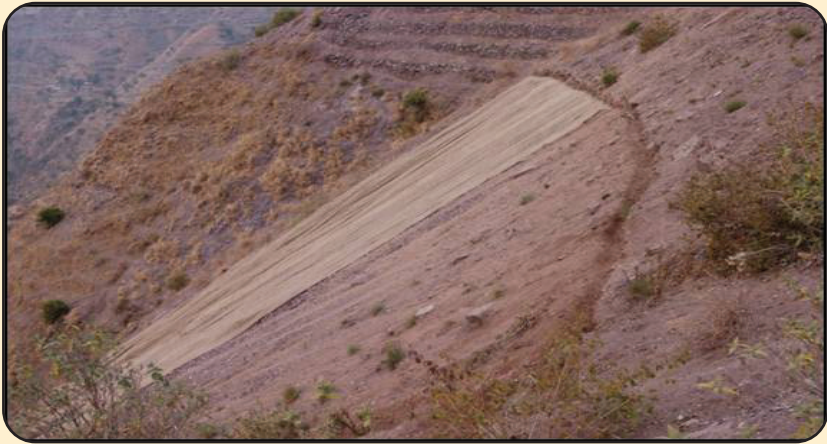
VIEW AFTER LAYING OF JGT

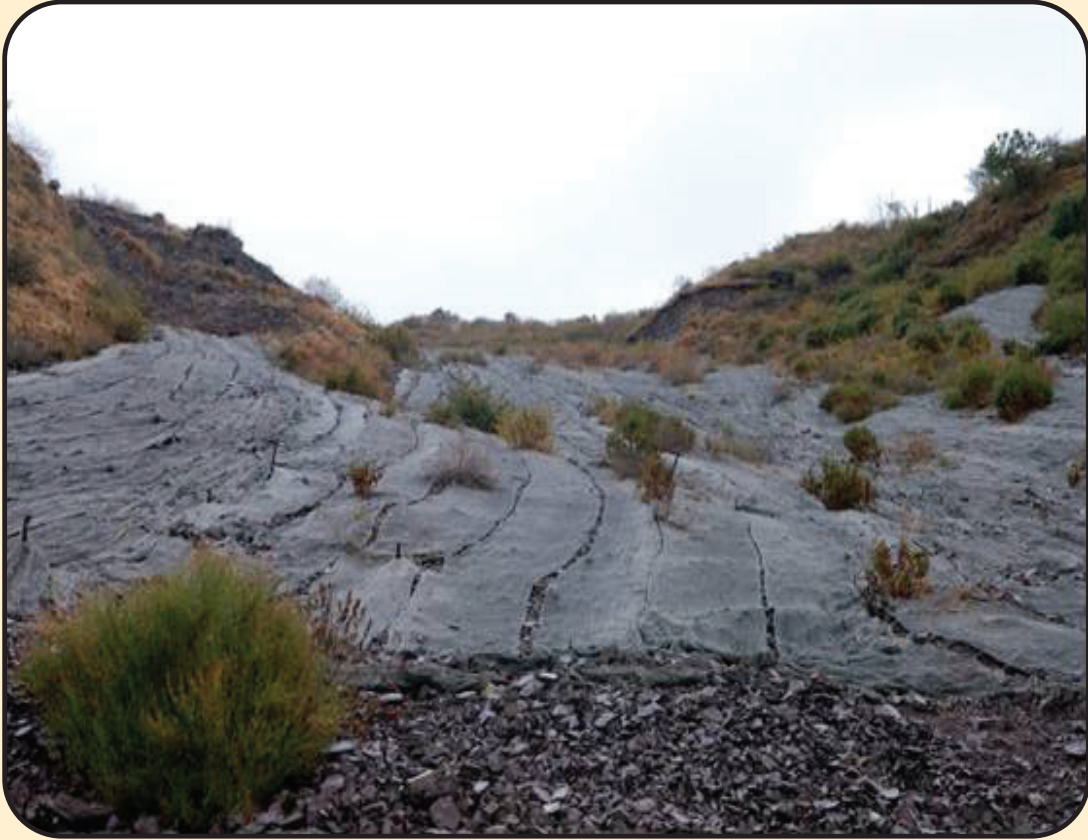
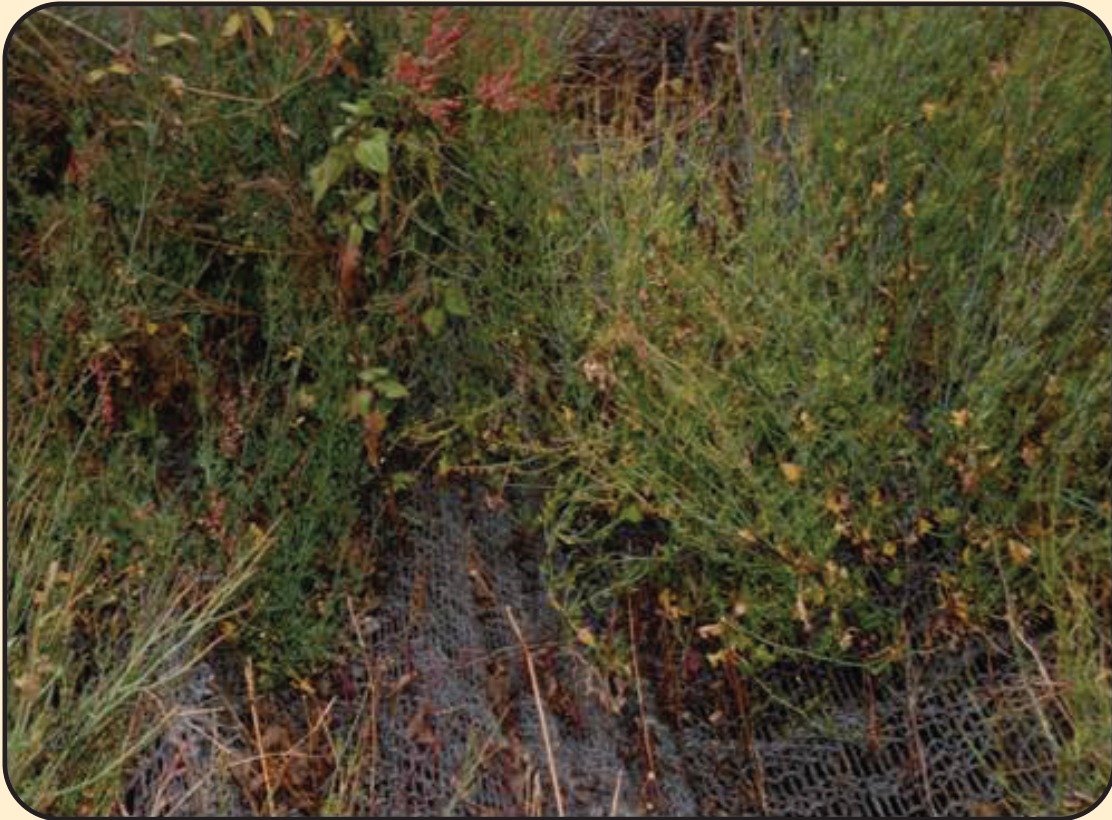
- No visible erosion taking place in the JGT area and no rills were observed.
- The JGT material was intact after one year of installation, though degradation in strength had taken place.
- The observations recorded so far indicate that JGT is effective in controlling soil erosion and help in growth of vegetation on degraded steep slopes even under open grazing conditions.
- Soil moisture (%) is more in OW JGT (700 GSM) by about 7.5 % compared to control
- Regeneration of vegetation and vegetation cover was more in JGT treated sites (700, 600,500 GSM in order) in comparison to Control section.
- JGT reinforced retaining/toe walls were intact at the lower portion.

VIEW OF STABILIZED SLOPE & GROWTH OF VEGETATION AFTER 1 YEAR
